Dumbarton Oaks Papers Number Sixty, 2006

*The Church of Hagia Sophia in Bizye (Vize): Results
of the Fieldwork Seasons 2003 and 2004*

Franz Alto Bauer and Holger A. Klein

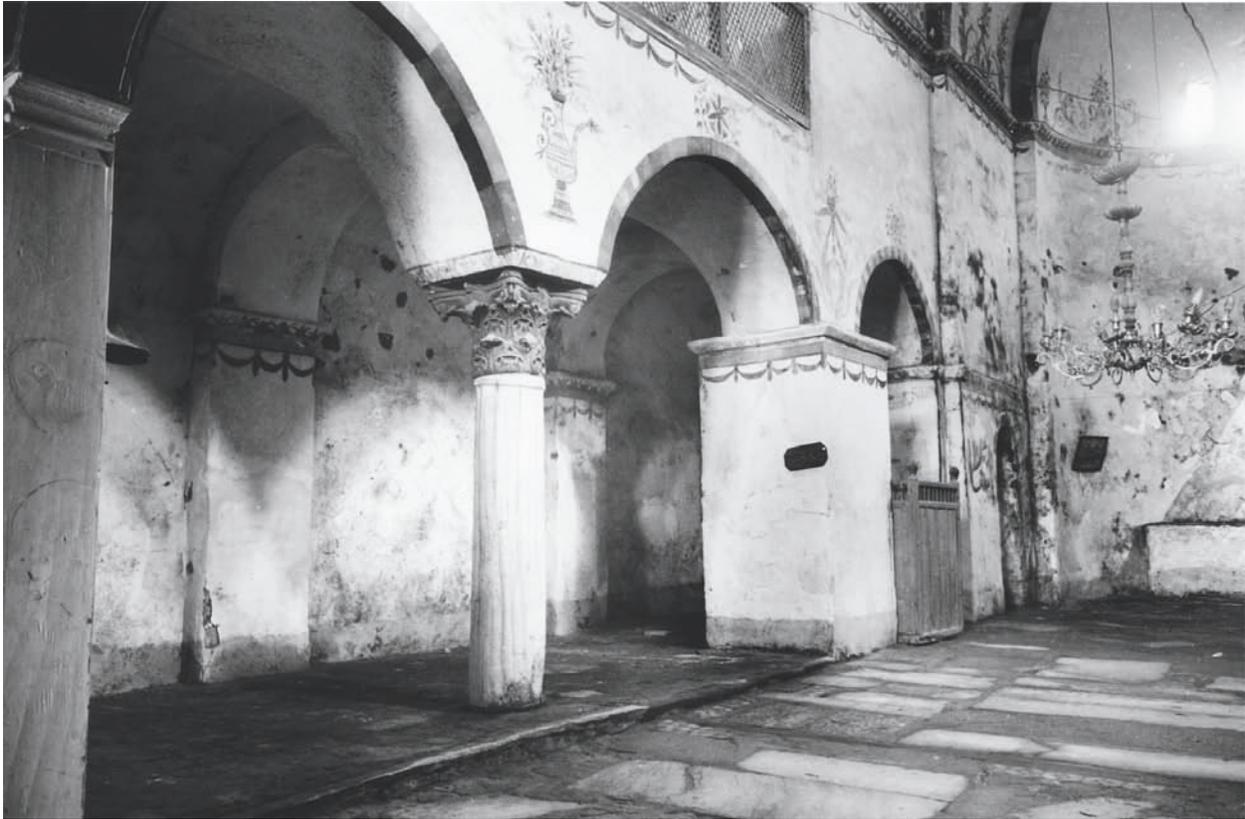
Fig. 6 Vize, Hagia Sophia, interior (photo: U. Peschlow)

up of joints between brick courses and stones on the building's north, south, and east façades;²⁷ (3) the restoration of the building's "original" appearance on the interior, which involved the removal of the raised Ottoman marble and opus sectile floor as well as the replastering of much of the unpainted wall surfaces, corner piers, and tympanum arches over the south and north galleries (figs. 5–6).²⁸

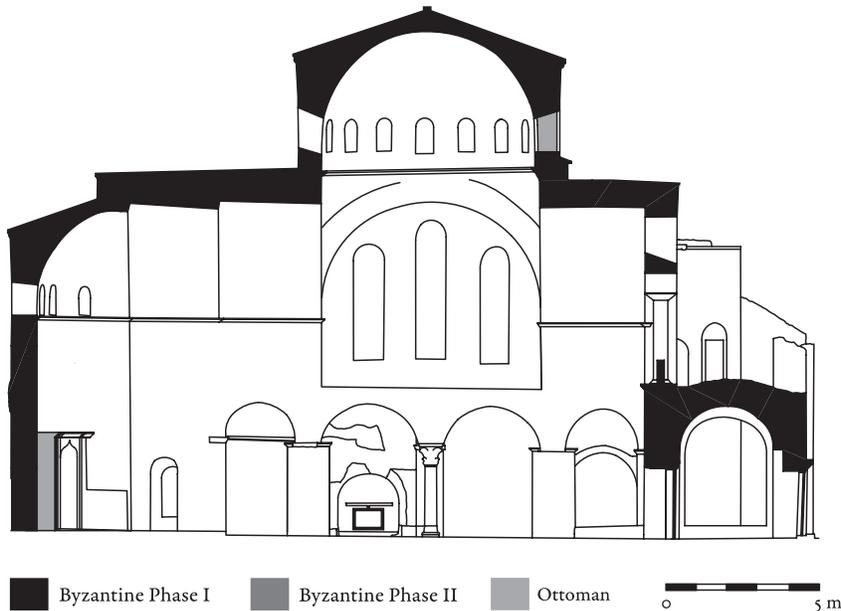
Fig. 9 Vize, Hagia Sophia, longitudinal section toward south (drawing: R. Rosenbauer)

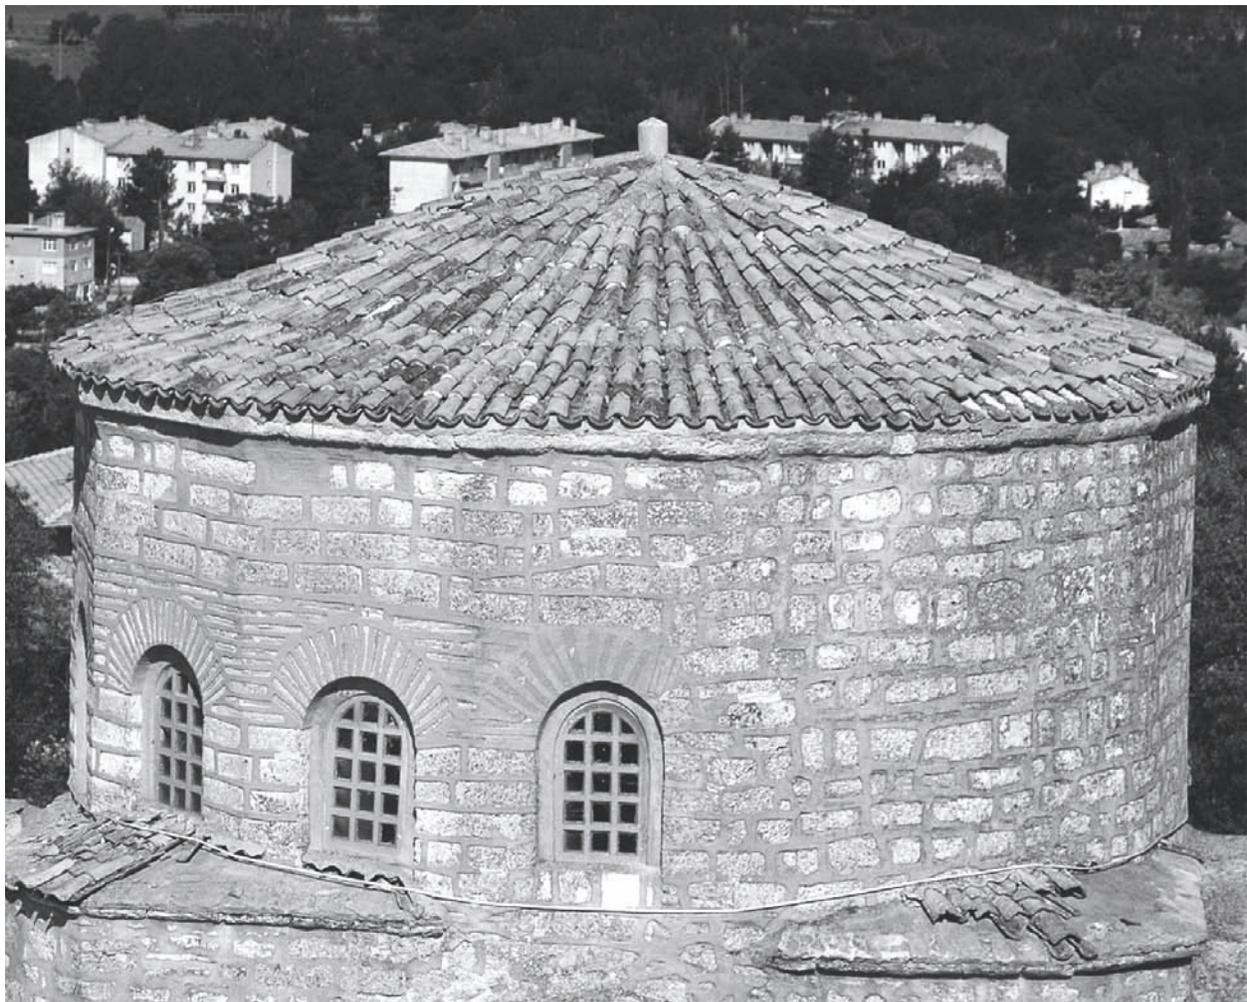
Fig. 10 Vize, Hagia Sophia, dome from east

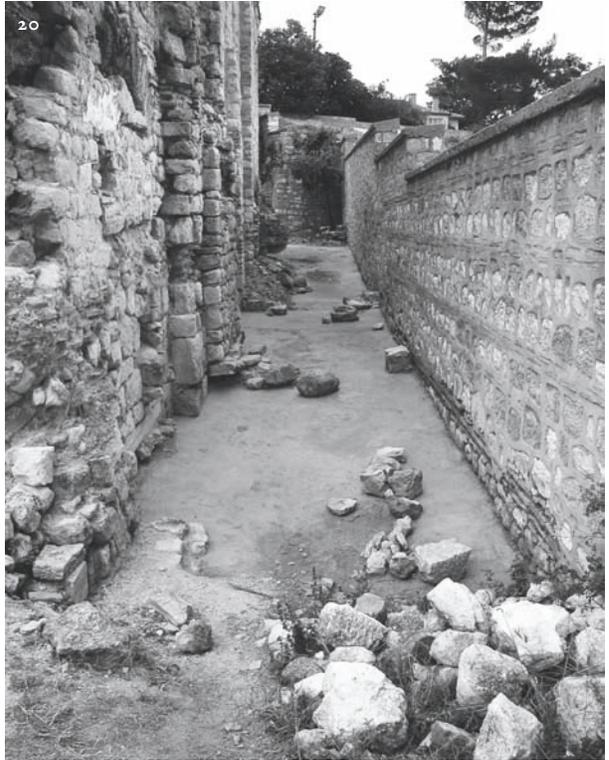
Fig. 20 Vize, Hagia Sophia, south corridor after cleaning in 2004

Work on the church continued during the second season of fieldwork in 2004 with a thorough cleaning of the brush and dirt that had accumulated for twenty-five years in the corridors flanking the north, south, and east façades (fig. 20). The cleaning, which was not only a prerequisite for a photogrammetric evaluation of the exterior façades of the building but was also expected to yield new information about the structure partially excavated during the Vakıflar restoration, led to the discovery of the remains of two walls that run parallel to the north and south aisles of the extant building (figs. 21–22).⁵⁰ In the early 1980s, these walls were used as foundations for the large retaining walls that now flank the church on both sides. As the orientation of the walls closely corresponds with that of the apse found to the east of the present structure, it might be presumed that they formed part of a

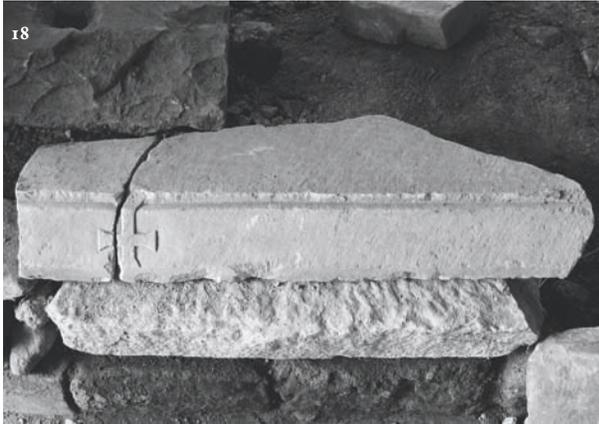
Fig. 18 Fragments of a lintel

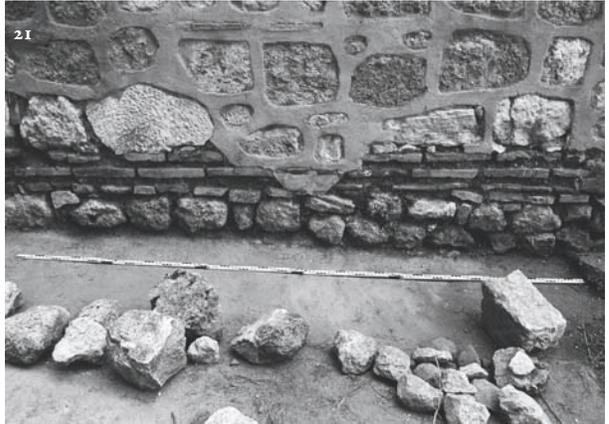
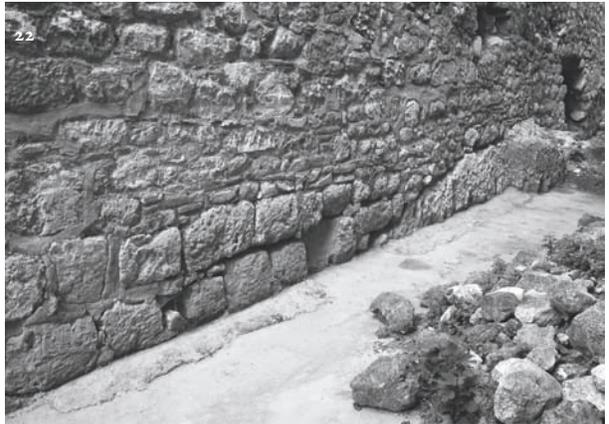
Figs. 21–22 Vize, Hagia Sophia, south and north corridors, detail of wall belonging to previous structure

50 At its western end the south wall rises to a height of about 0.30 m and consists of two layers of ashlar blocks topped by a band of three to four bricks with wide mortarbeds. The north wall consists of larger ashlar blocks and incorporates sections of worked bedrock.

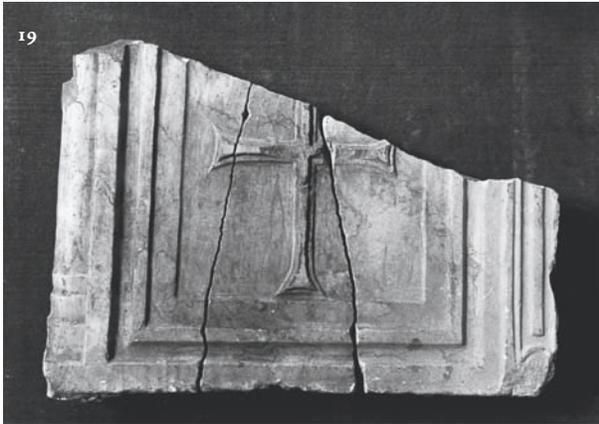
Fig. 19 Fragments of a marble screen

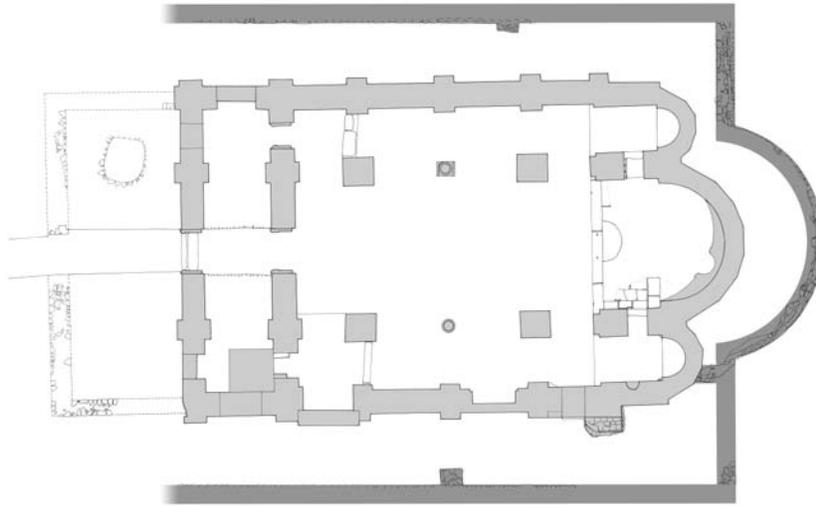
Fig. 23 Vize, Hagia Sophia, ground plan with remains of previous structure (drawing: R. Casagrande)

basilican structure that preceded the present church. The cleaning of the corridors and the main apse of this building allowed for the first time the drawing of an accurate plan of the remains of this structure (fig. 23), previously recorded in a sketchy drawing by Yıldız Ötügen and Robert Ousterhout.⁵¹
